“No Cool” Hard Lockout Reset Procedures For the 628661-Power Board

03/17/06

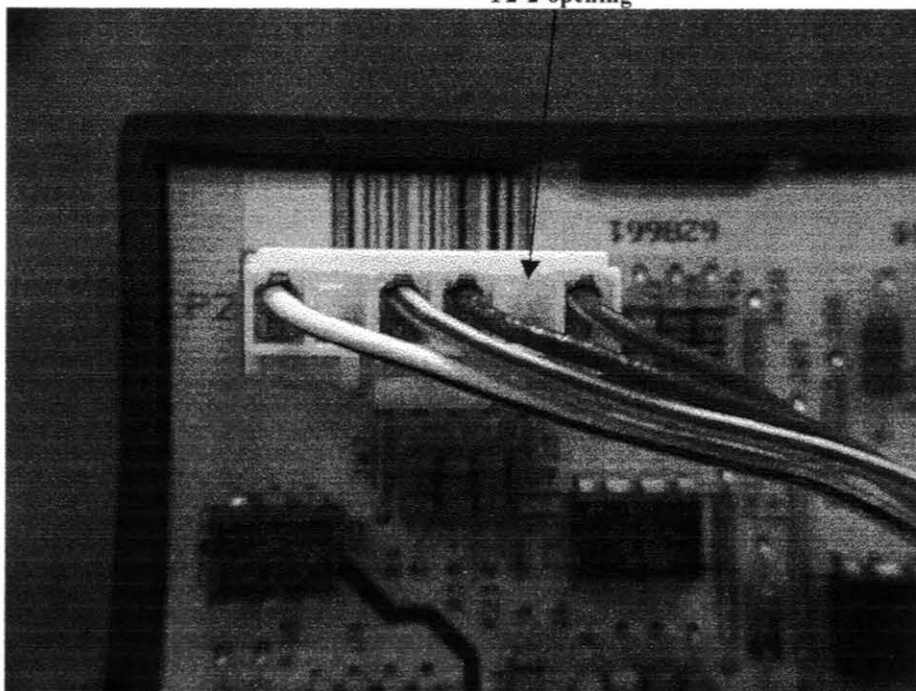
“Hard Lockout” Reset Procedure 2: Done via the power board

(Can be done on all models)

With the refrigerator powered ON and operating in the Manual AC Mode (AC power cord disconnected from the power board);

1. Insert one end of a piece of multi stranded wire (10 gauge works well) whose insulation is stripped ½” on both ends, into the P2-2 opening and hold into place.
2. Place the other end of the multi stranded wire to ground (metal back panel) and hold it in place for a minimum of 10 seconds.
